REI ENGINEERS

Infrared Moisture Evaluation St. Petersburg College 14025, 58th St N, Clearwater, FL 33760

Date: October 27, 2014

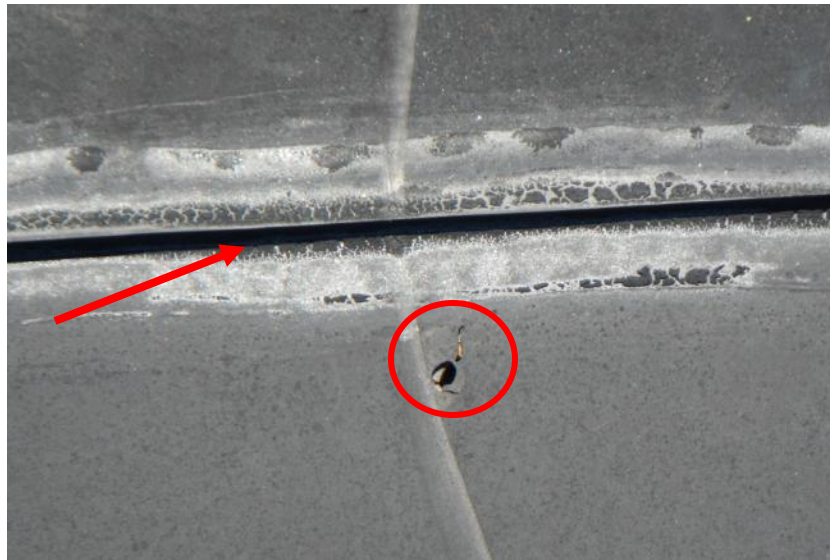
1. Holes, splits, and failing seams in the EPDM single ply membrane were observed during REI's site visit. All of the seams are curling and the adhesive bond between them is deteriorating.

Observation Photograph 1 – Circle indicates a hole/split in the membrane and arrow indicates the curling/deteriorated seams.

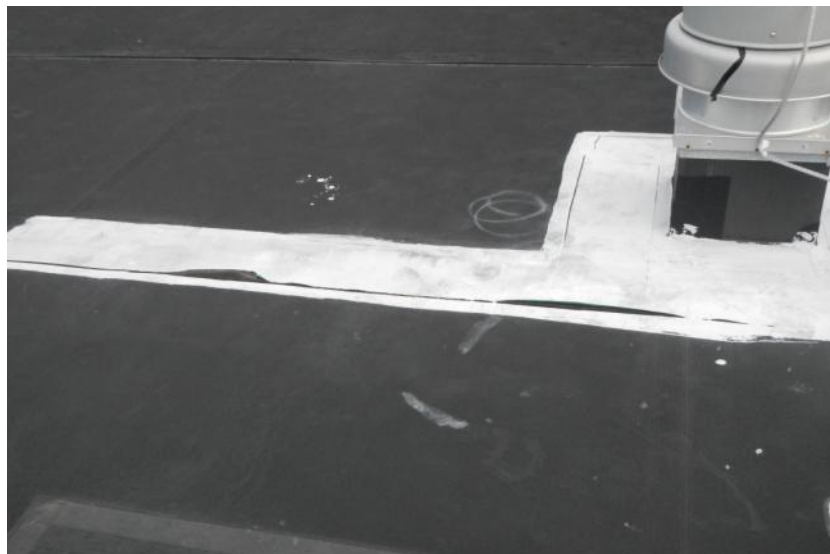
2. Patches and coatings have been installed in an attempt to make repairs. These patches and coatings are also failing and the edges are curling.

Observation Photograph 2 – This patch is curling around the perimeter, and a coating has been applied to the surface.

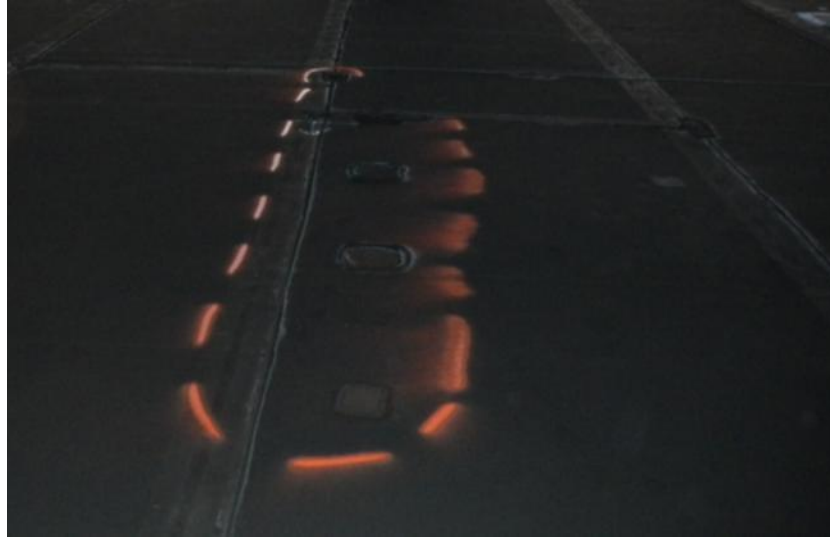
3. Multiple patches have been installed throughout the roof sectors. These patches often showed up as thermal anomalies in the infrared camera viewfinder and were marked as such. Further investigation with a moisture meter would later find these areas to be dry.

Observation Photograph 3 – View of typical patching throughout the roof system and paint marking for further assessment.

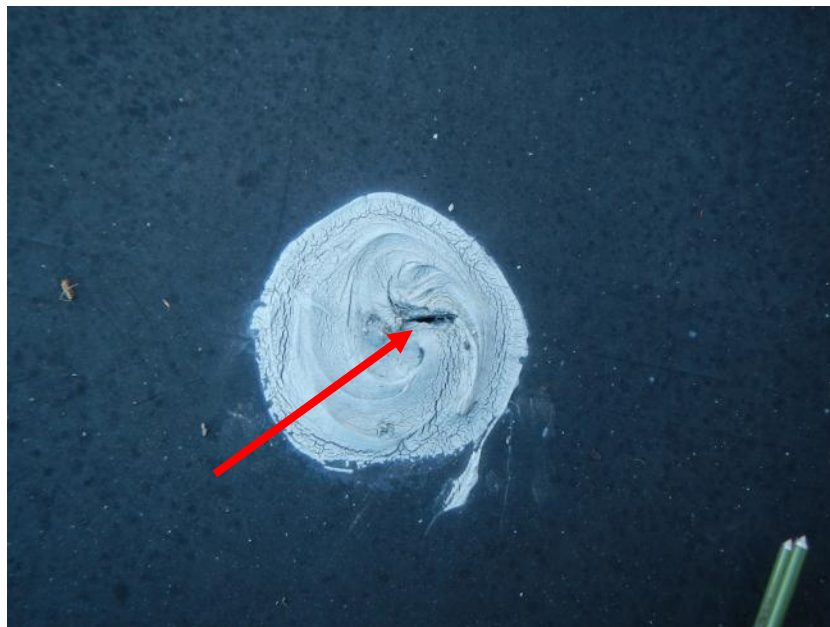
4. Holes and splits in the EPDM membrane, similar to Observation Photo #1, were also observed on Sector S2. Surface applied sealant is used at a few locations in an attempt to make repairs as seen in this photograph.

Observation Photograph 4 – View of EPDM membrane opening with surface applied sealant.

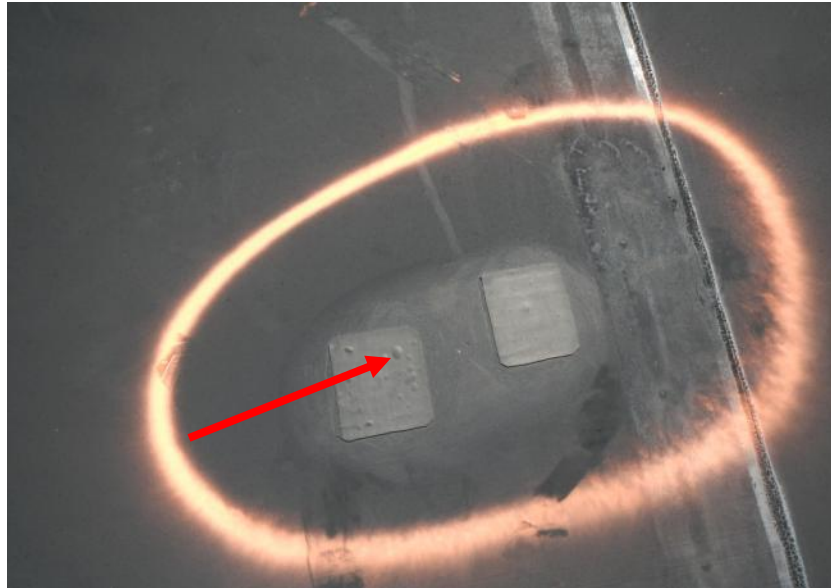
5. Numerous patches have also been installed on Sector S2. The patches in this image appear to have been installed somewhat recently; however, blisters are visible in the patching material.

Observation Photograph 5 – View of typical patches on S2. Arrow indicates blisters in patch.

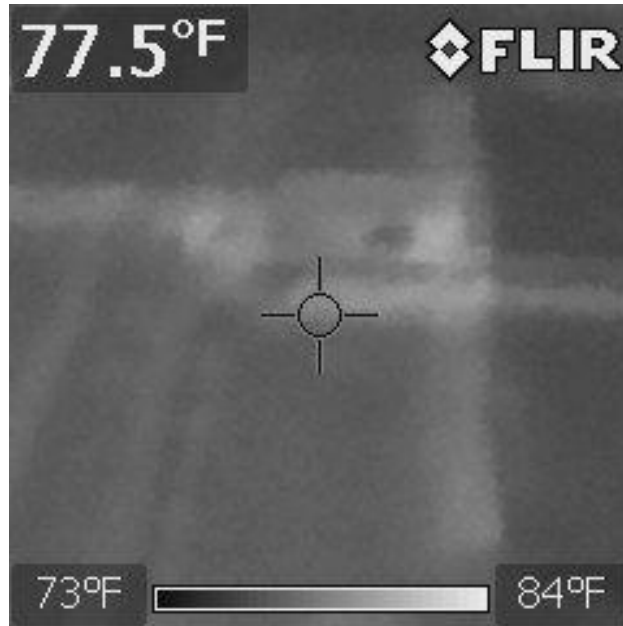
6. View of a thermal anomaly around a membrane patch and along patched membrane seams.

IR Photograph 6 – View of typical thermal anomaly observed.

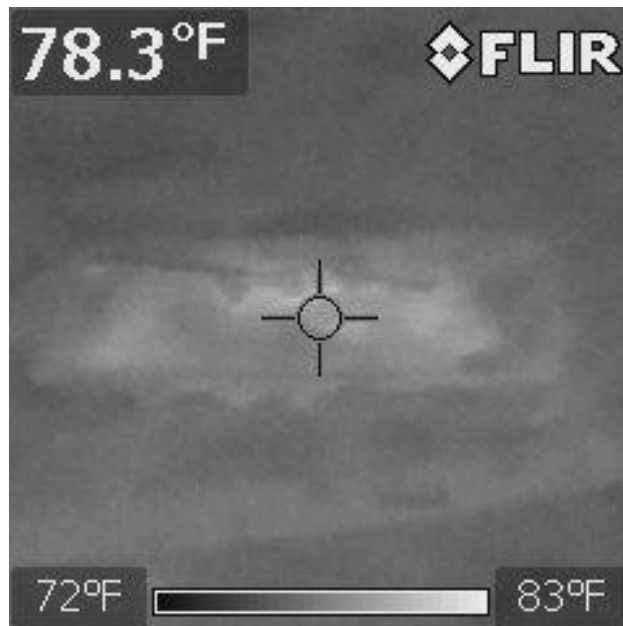
7. View of a thermal anomaly at an EPDM membrane patch.

IR Photograph 7 – Note the rectangular area of lighter color.

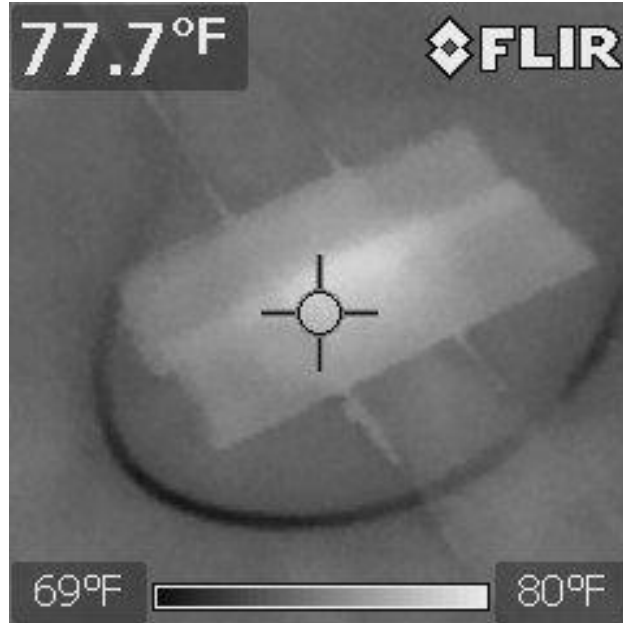
8. Photograph of an EPDM membrane patch installed over a membrane lap. The rectangular overlapping patches are well defined in this view, and a higher temperature is evident at the overlapping seams where there is a buildup of patching material. This area was marked with spray paint (darker ring around light colored patch) for further assessment.

IR Photograph 8 – Infrared view of typical membrane patch.

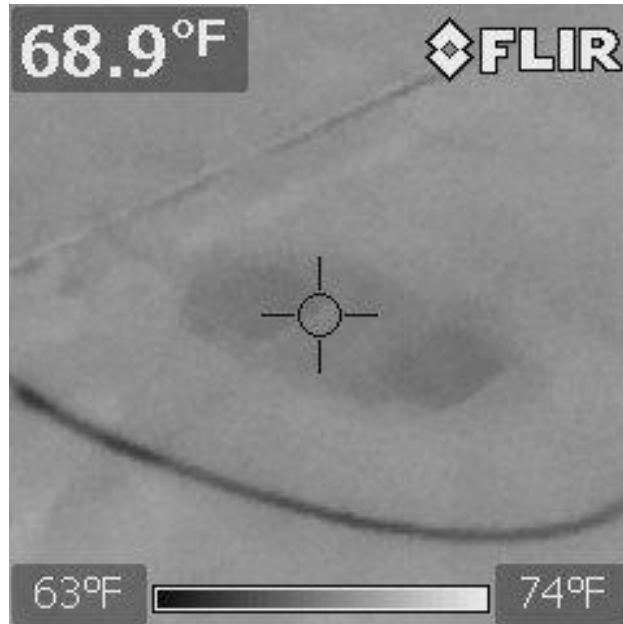
9. View of a thermal anomaly on Sector S2. A darker area is visible in the center of this image. Typically, moisture in a roof system remains at a higher temperature than the surrounding roof surface which is viewed as a lighter color in the infrared camera viewer. The darker section of this photo indicates a lower temperature than the surrounding roof surface so the location was marked with spray paint for further assessment. This area consists of two patches and correlates with Observation Photo #5.

IR Photograph 9 – View of a paint marked area in which a lower temperature was observed.

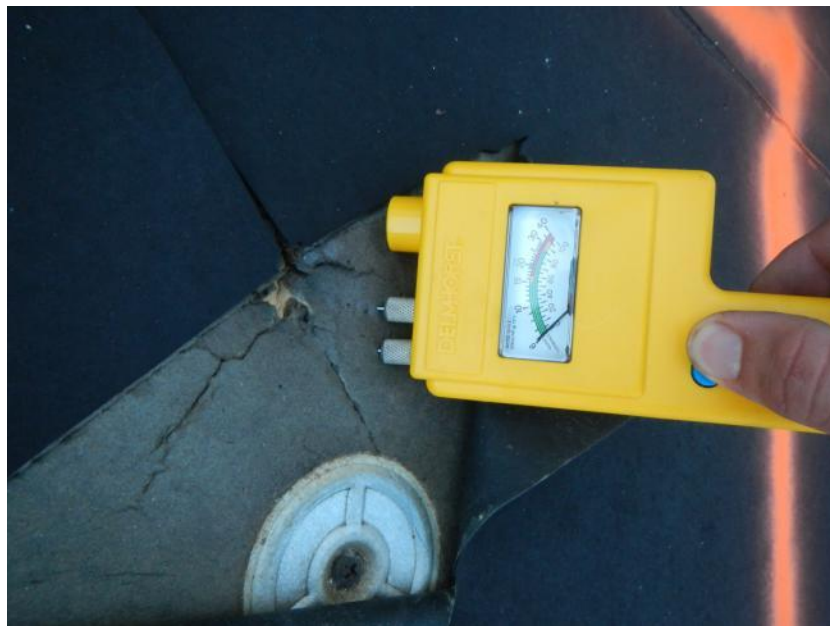
1. Opening No. 1 was taken along the base flashing approximately 30' east from the northwest wall. This location had a hole in the membrane similar to Observation Photograph #1. Based on REI's observations, the polyisocyanurate insulation appears to have been previously wet but was dry to the touch. The fastener and insulation plate in the opening has evidence of rust and corrosion typically caused by coming into contact with moisture. However, the moisture meter detected no moisture in this opening.

Locations that were observed by REI to have holes, splits, or openings in the membrane were opened and assessed for moisture content with the Delmhorst moisture meter. These locations all returned the same results as the opening in this photograph in which no moisture was detected.

Opening Photograph 1 – The Delmhorst moisture meter showing a reading of no moisture.

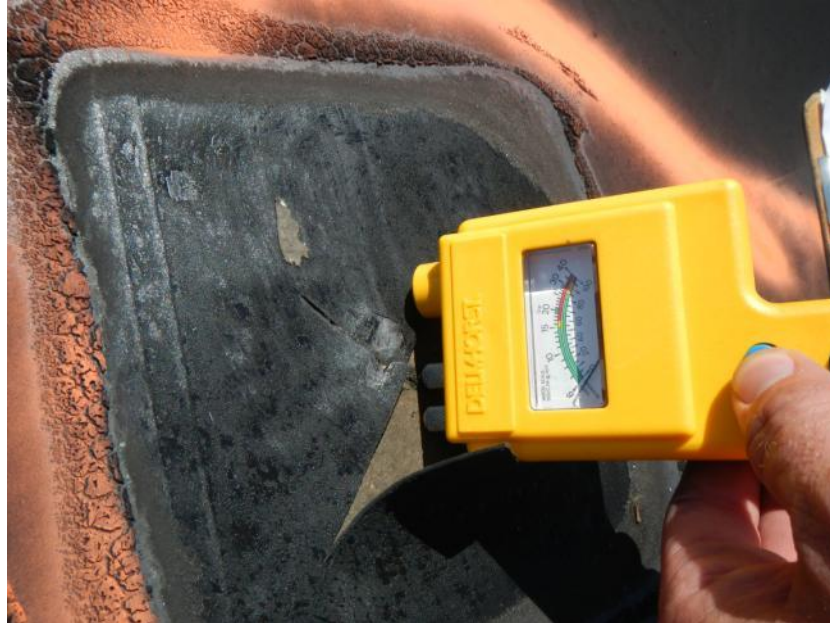
2. Opening No. 2 was taken approximately 25' east and 20' south of the northwest corner at the location of a patch that was marked as a thermal anomaly similar to Photograph #3 under Sector S1 Infrared Photographs. The moisture meter detected no presence of moisture at this location.

Opening Photograph 2 – Moisture meter reading no moisture content at this patch.

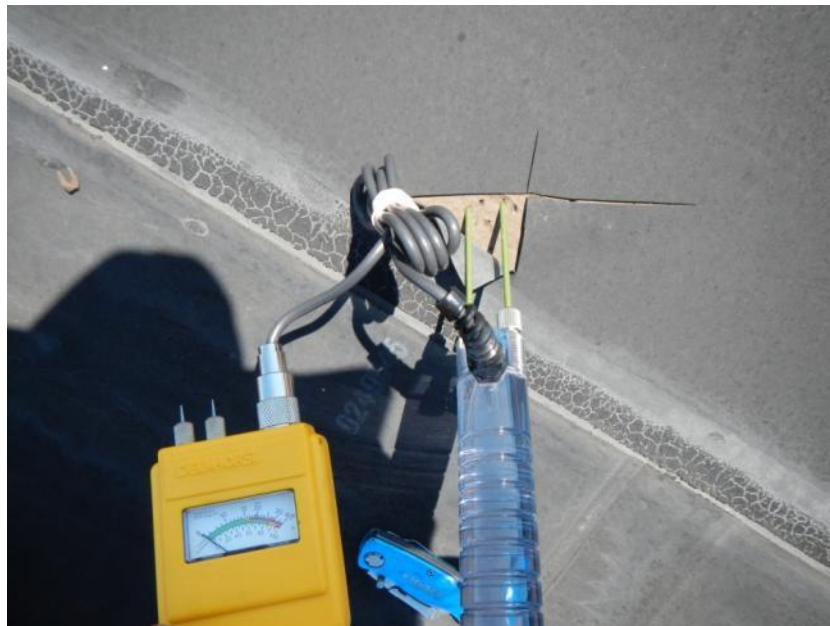
3. Opening No. 3 was taken approximately 35' west and 25' south of the northeast corner. This photograph shows the use of the 6" long probe used to measure moisture content at varying depths in the insulation. The moisture meter detected no moisture at all depths of the insulation for all openings made.

Opening Photograph 3 – Moisture meter reading using the 6" long probes.

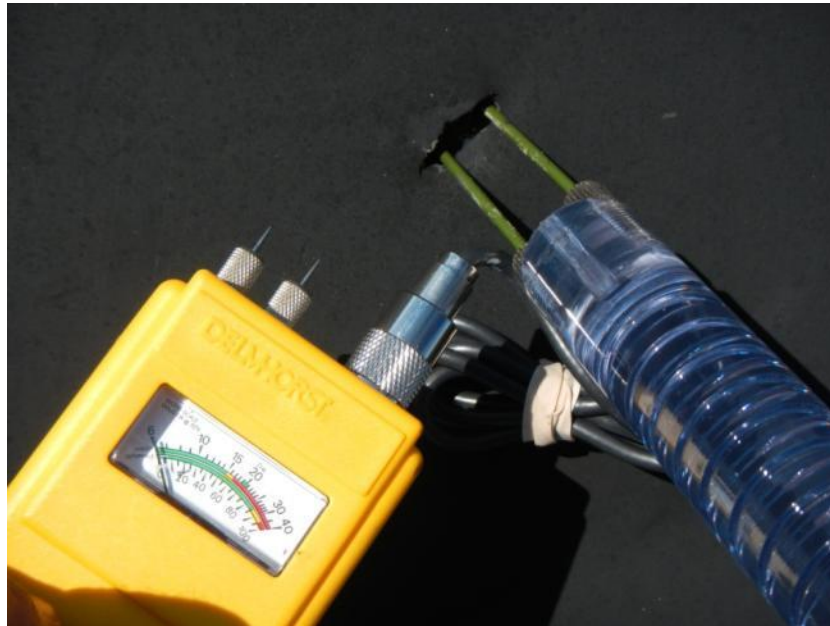
4. Opening No. 4 was approximately 30' south and 10' east of the northwest corner on Sector S2. This opening was an existing hole in the EPDM membrane that did not show a thermal anomaly during the infrared scan. Similar to the prior moisture tests, the moisture meter did not detect any moisture at varying depths in the insulation.

Opening Photograph 4 – Moisture meter reading using the 6" long probes in an existing membrane hole.

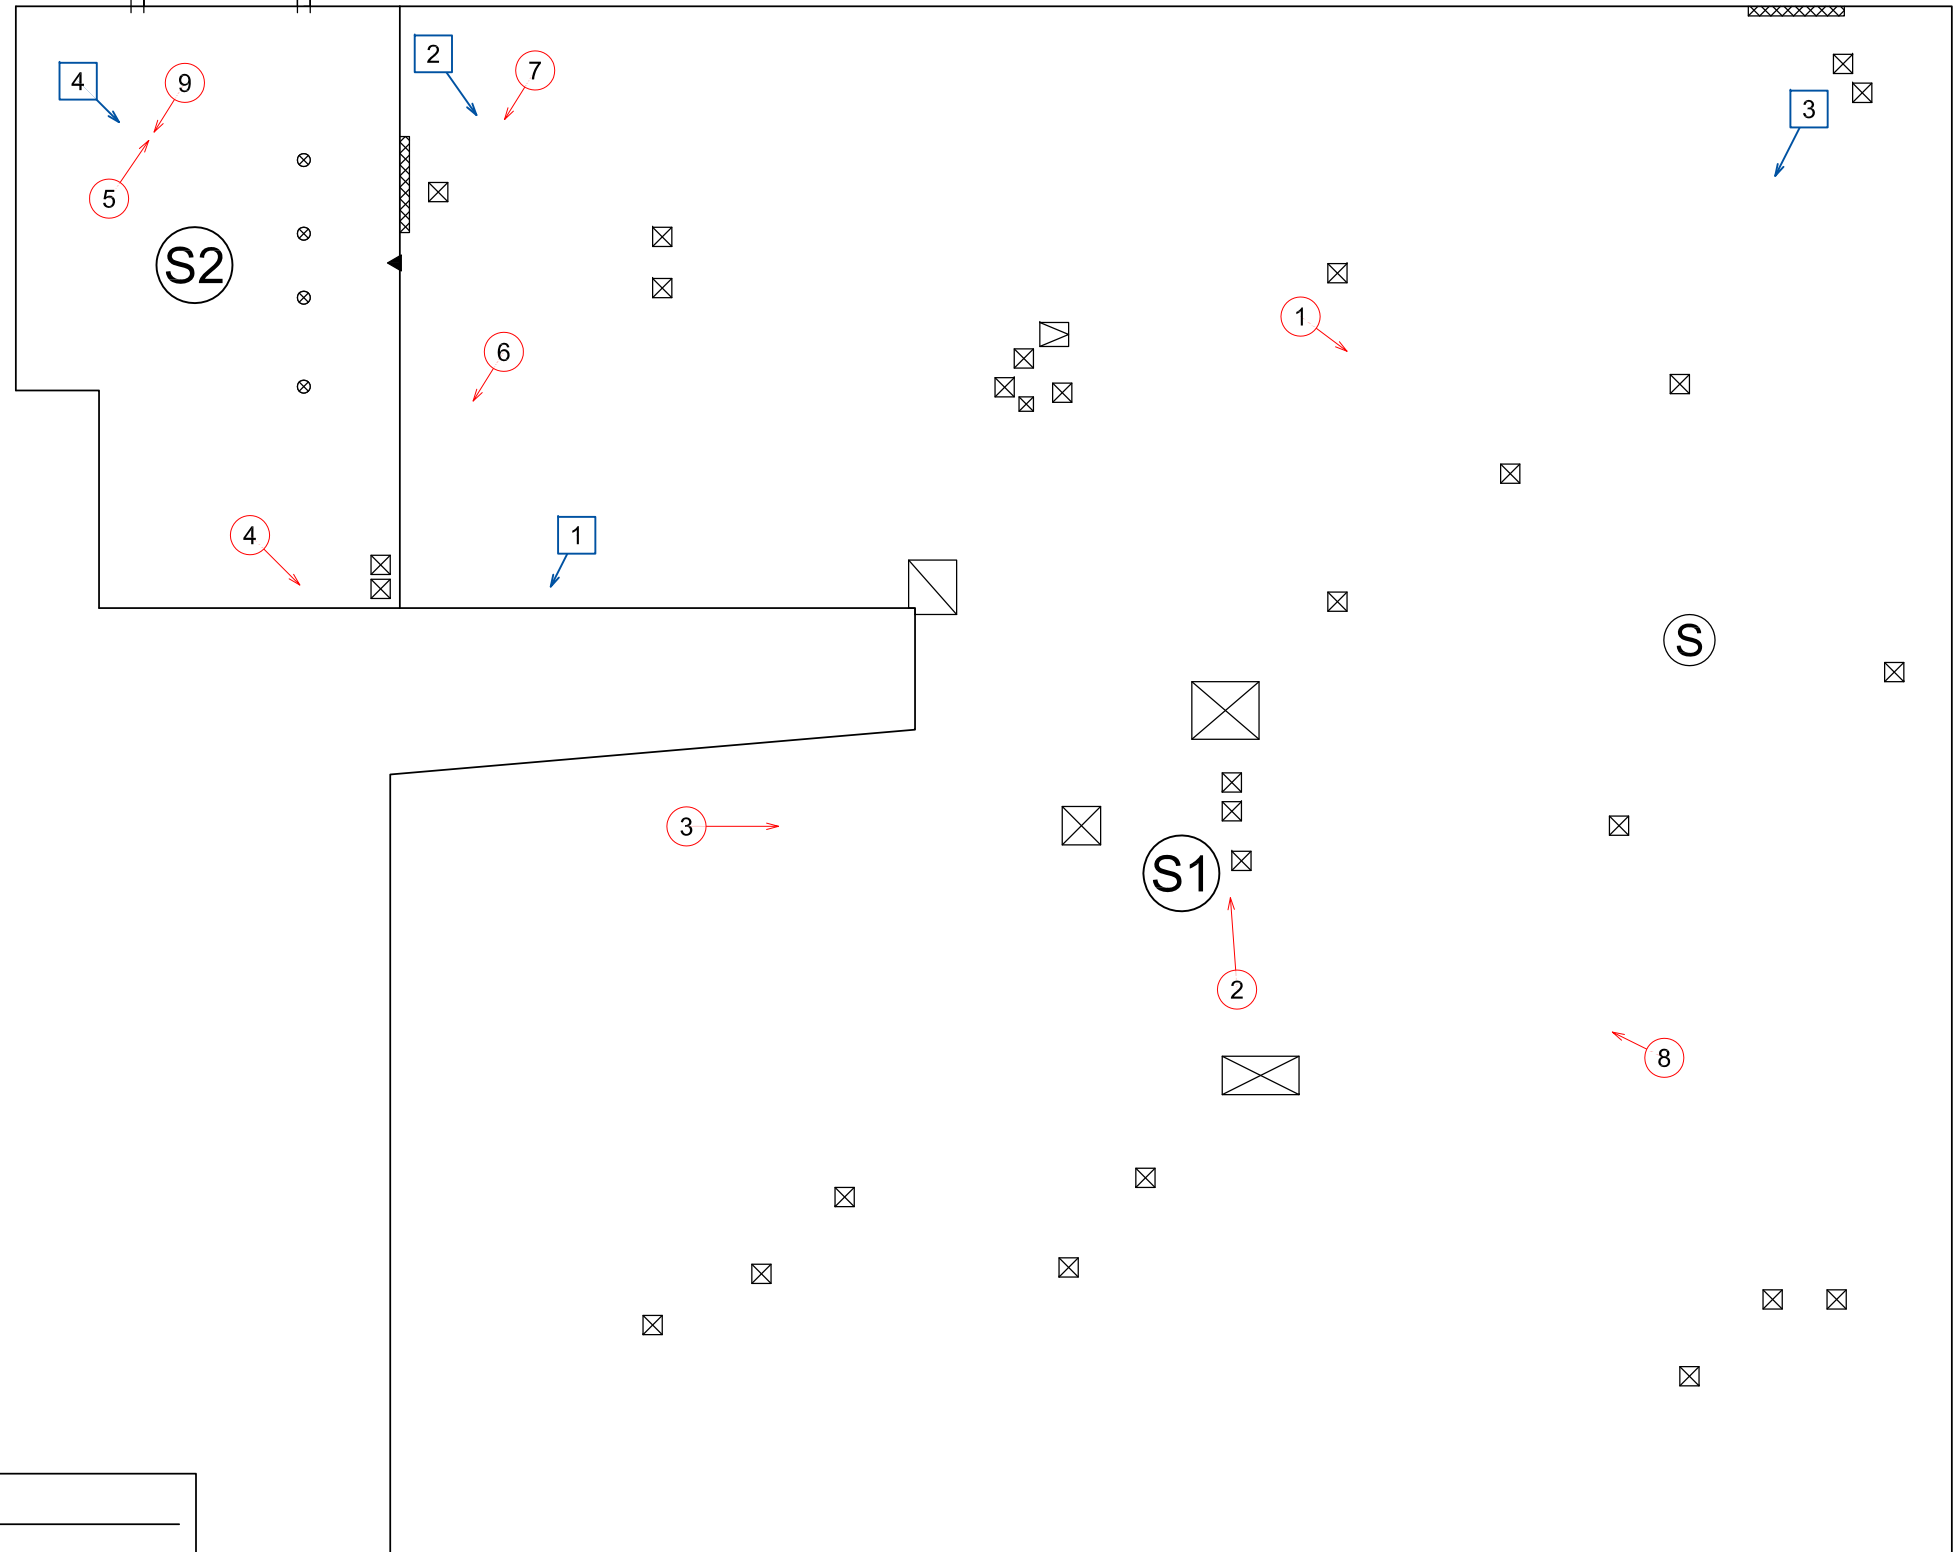
1 ROOF PLAN - SECTORS S1& S2
A 1"=30'

A roof plan showing the building outline, approximate locations of curbs and penetrations, openings, infrared anomalies, areas of standing water during the survey, and other specific information is contained on the following page.
